MT GIBSON IRON ORE MINE AND INFRASTRUCTURE PROJECT

ANNUAL ENVIRONMENTAL REPORT

**Mt Gibson Iron Ore Mine and
Infrastructure Project
October 2022 – September 2023**

Revision Date: 30th October 2023

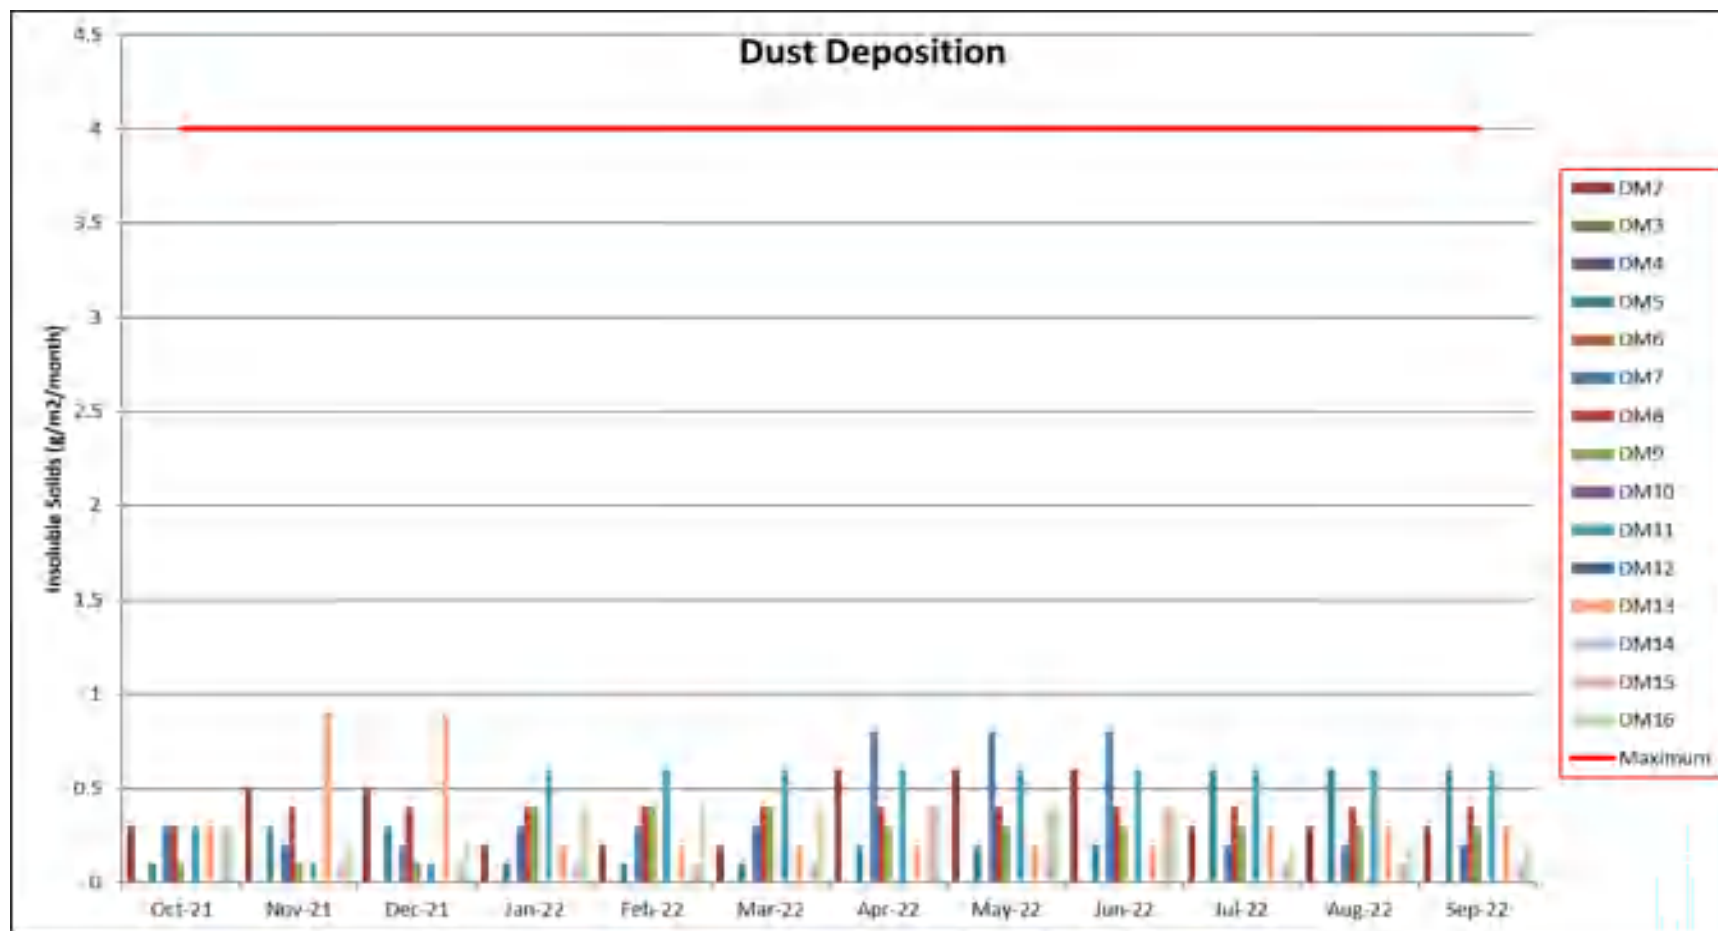
Figure 6 Dust Deposition Data in the final year of site monitoring

As stated in MGM (2020), dust deposition monitoring data was only required to be collected and reviewed for one year following cessation of EHHO mining operations, and if no impacts were detected during that final period, the monitoring would cease. No impacts were detected so all dust deposition gauges were decommissioned in October 2022. The results for the preceding final year are shown in Figure 6; these show low ambient levels of dust accumulation all around the EHHO site.

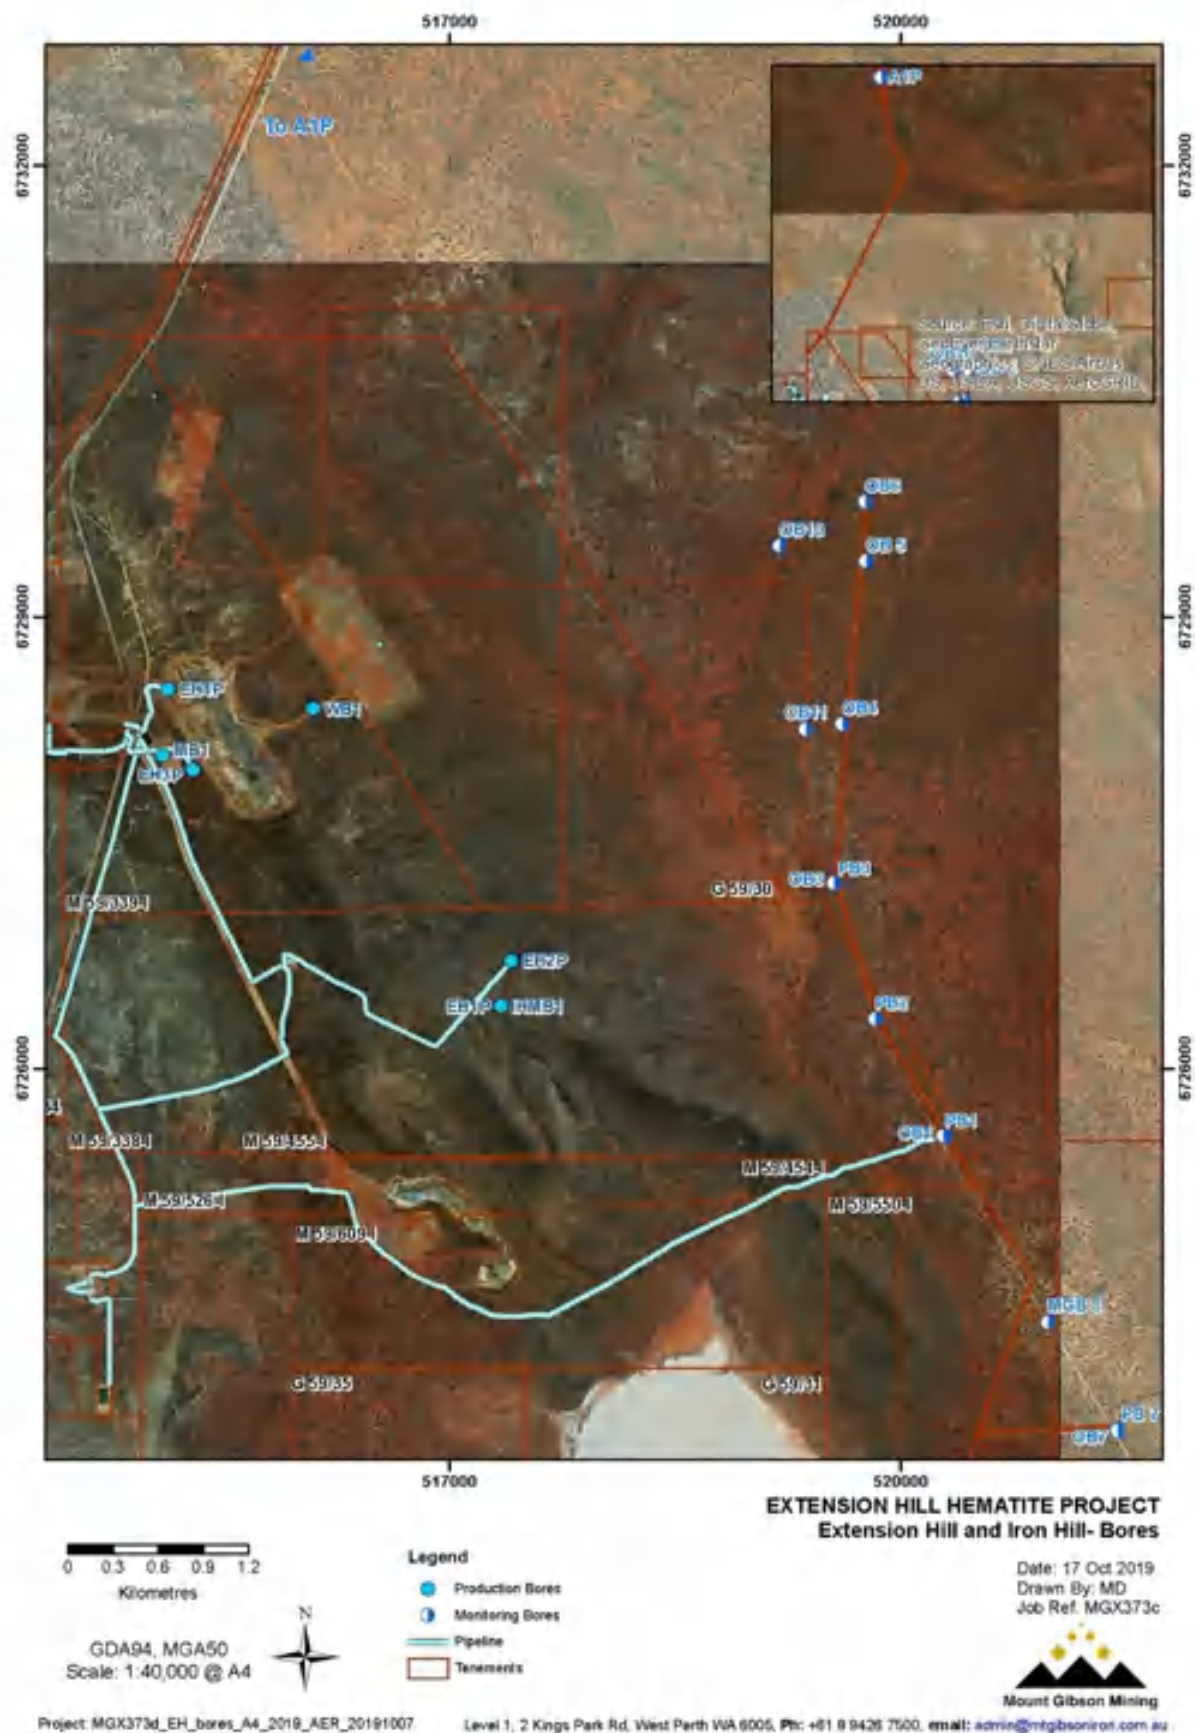
Figure 7 Groundwater Bore Locations

PB1 bore in a nearby borefield was not required during the period. Groundwater abstraction from PB1 ceased in December 2018. Previous use of this bore triggered a requirement under the Department of Water and Environmental Regulation Groundwater Licence to also monitor bores MGB8, PB1, PB2, PB3, PB7, OB1, OB3, OB5, OB6, OB10, OB11 and A1P. Monitoring was only required to be completed twice during the reporting period. The locations of all groundwater bores are illustrated in Figure 7.

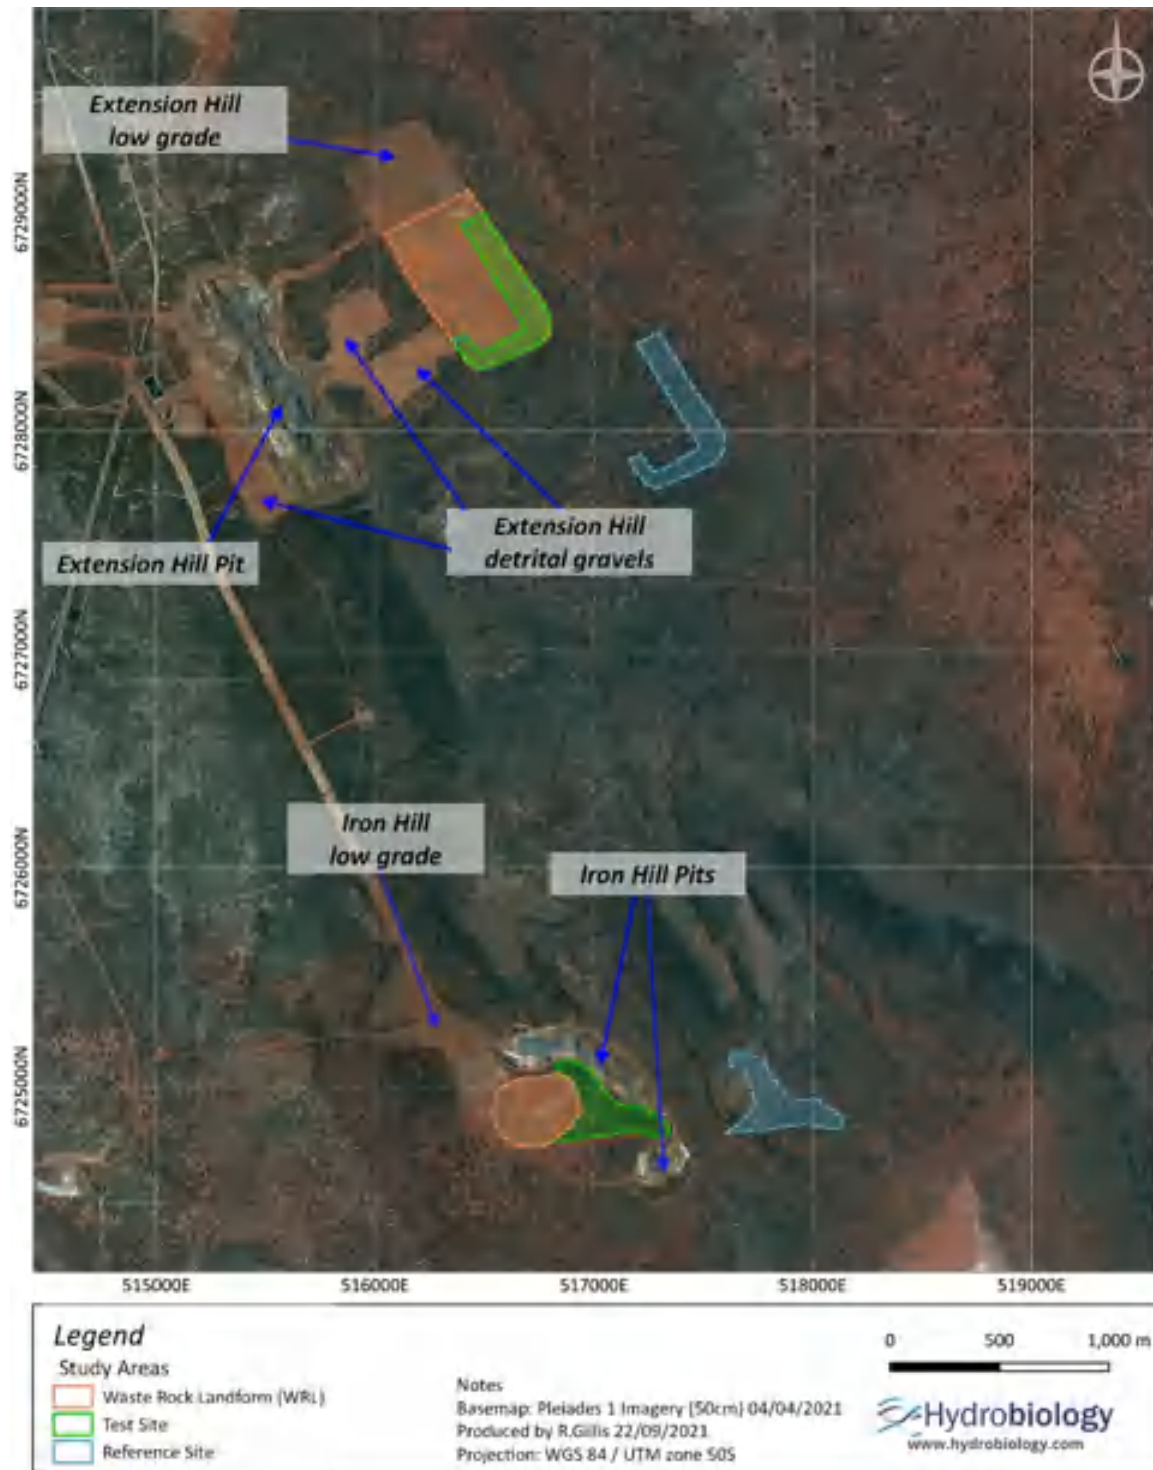
Figure 14 Extension Hill (EH) median NDVI results over time for the Waste Rock Landform – orange is WRL flat top, green is outer slope and blue is adjacent natural woodland Reference area

Sentinel-2 multispectral imagery was acquired on a monthly basis from January 2016 to October 2022 to capture potential changes in vegetation quality at reference (ie. natural) and test (direct and indirectly disturbed) areas. The Normalised Difference Vegetation Index (NDVI) was calculated as a proxy for vegetation cover and foliage quality as it provides a reliable and consistent measure of chlorophyll content. The assigned areas of similar setting, shape and areas are shown in Figure 13. The rehabilitated areas (landforming; dressing; ripping; seeding) were completed from 2015 onwards, so up to six years of progression in revegetation is evident.

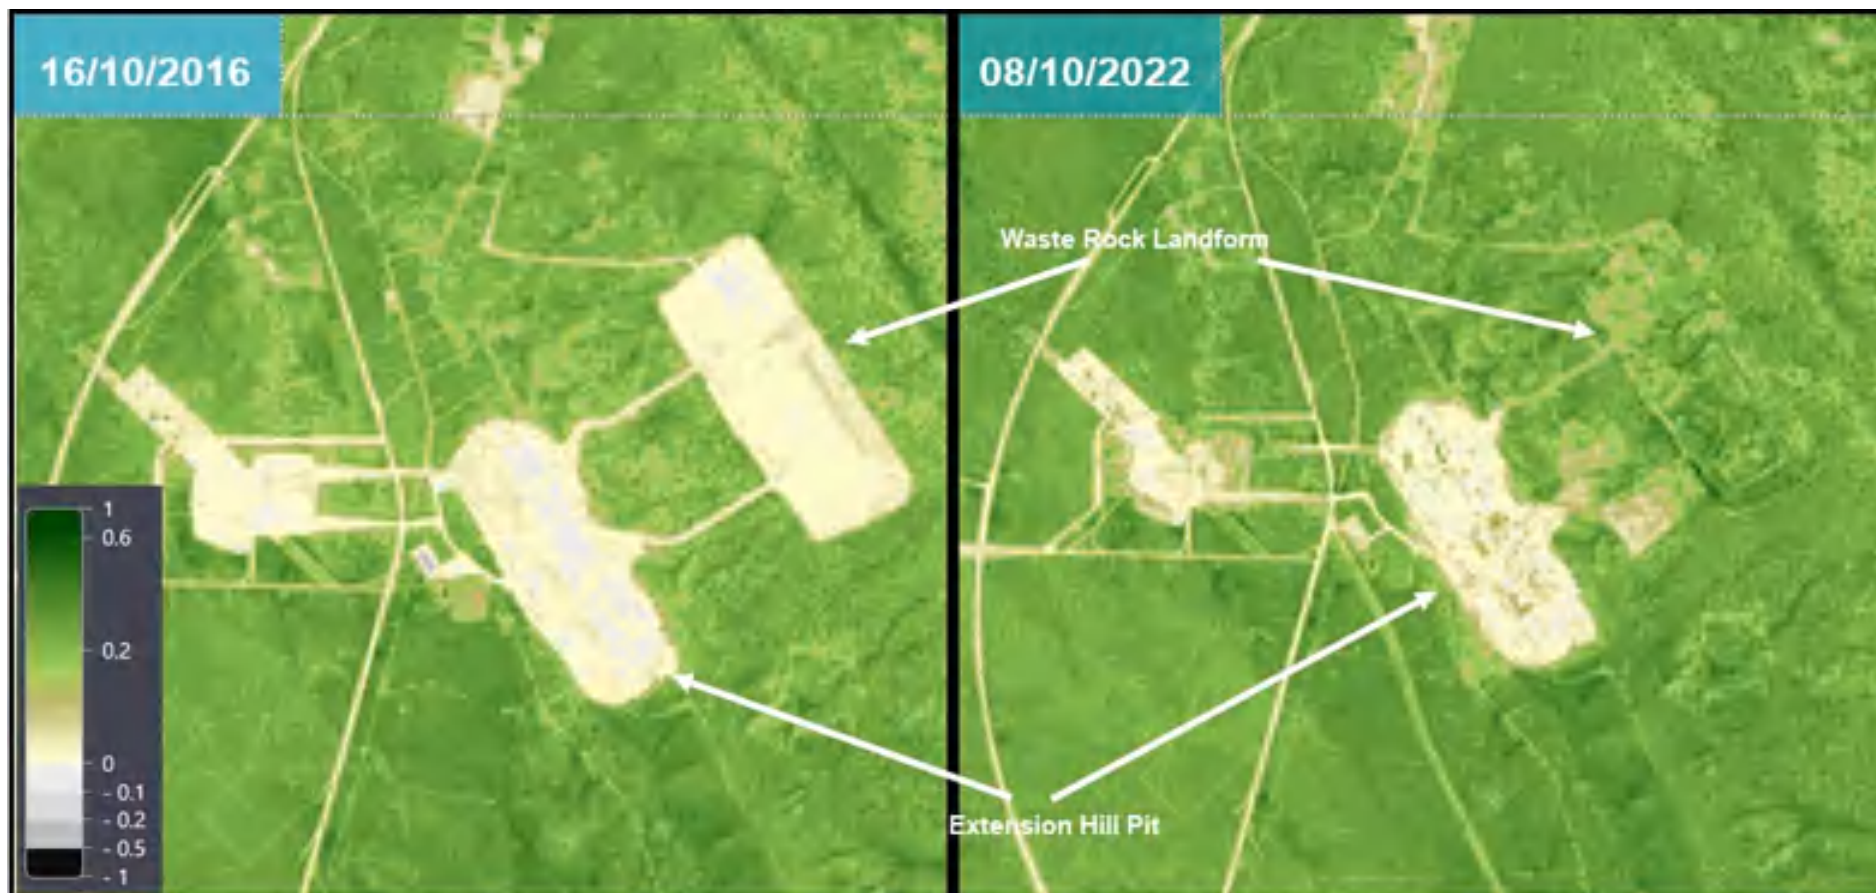
Figure 15 shows a false colour rendering of the cover of different vegetation densities. The effect of rehabilitation and vegetative regrowth is clearly evident over the course of six years.

Figure 15 Comparison of vegetative quality (NDVI) in late October 2016 to October 2022
at the Extension Hill study areas (dark green shows highest foliage cover; grey/yellow is bare land).

Rehabilitation of vegetation at the Extension Hill waste rock landform progressed steadily in the period under assessment. A substantial increase in vegetation cover and quality was observed. This can be attributed to above-average rainfall in the region.

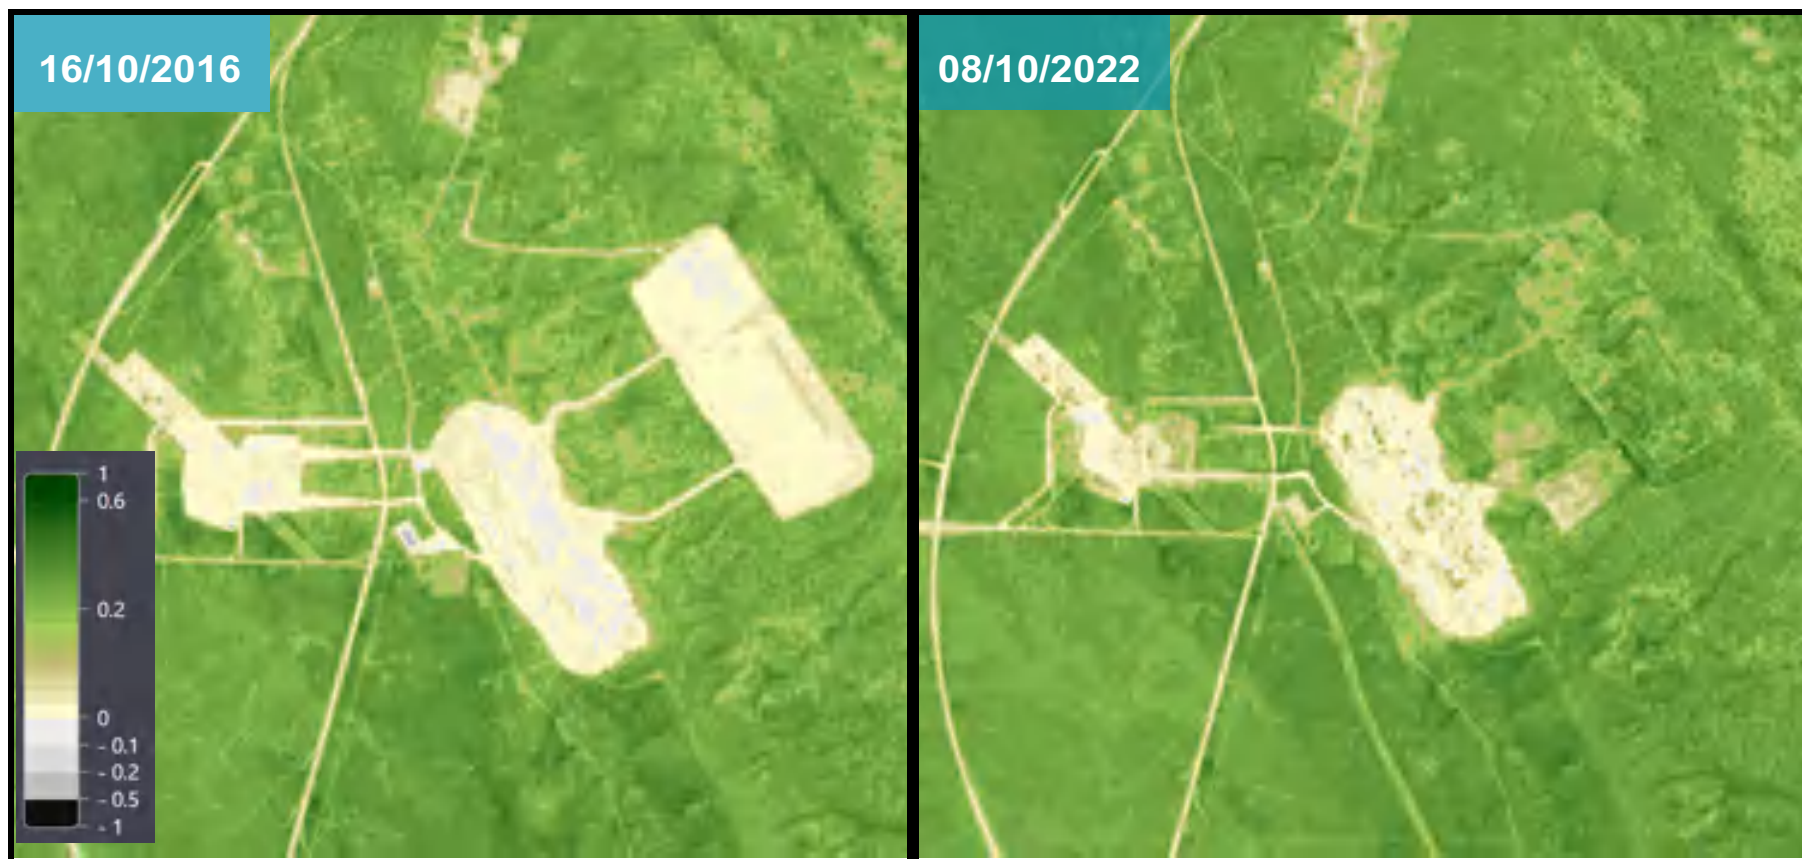
Figure 5 Comparison of vegetative quality (NDVI) in October of 2016 and 2022 at the Extension Hill study area.

NDVI results at Extension Hill are presented in Figure 4 and raw data (per month) in Appendix A. The increase in vegetative quality and progression of rehabilitation programs from late-July 2016 to August 2021 can be seen in Figure 5.
