## MT GIBSON IRON ORE MINE AND INFRASTRUCTURE PROJECT

# FIVE YEAR PERFORMANCE REVIEW REPORT Mt Gibson Iron Ore Mine and Infrastructure Project 2020

Document	Performance Review Report – Mt Gibson Iron Ore Mine and
Title:	Infrastructure Project 2020

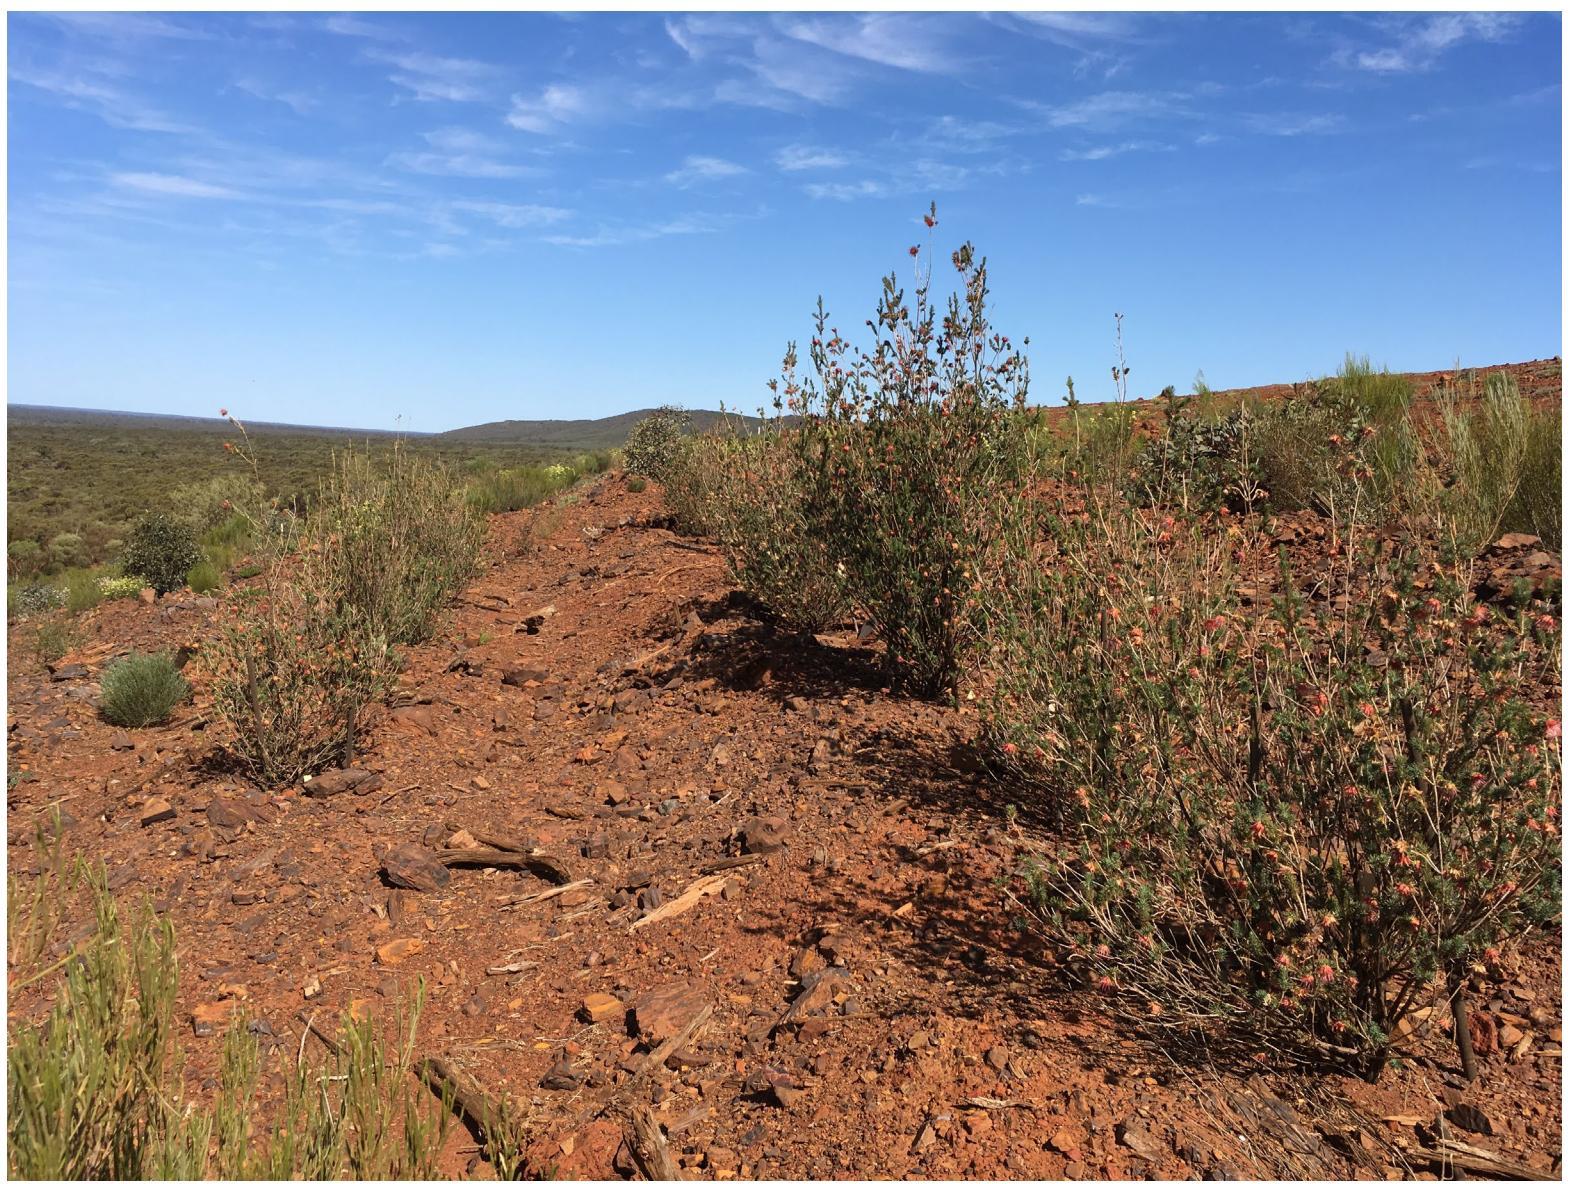
Plate 1 Extension Hill WRL Darwinia Masonii translocation trial (September 2019)

"Monitoring of the Darwinia masonii trial translocation to the Extension Hill WRL continued during the reporting period. The trial was commenced in June 2015 by translocating 15 Darwinia masonii that were naturally growing in topsoil stockpiles to the WRL and including five additional Darwinia masonii that were grown in a nursery from cuttings as control plants. All 20 plants are still alive and 18 were recorded flowering on the 26<sup>th</sup> September 2019. The average total growth from the commencement of the trial to 26<sup>th</sup> September 2019 is 102.8cm. The results to date continue to indicate that Darwinia masonii is capable of surviving transplantation of wild grown seedlings and that the WRL cover material is suitable for the survival of these plants."

Plate 1 illustrates the status of the Extension Hill WRL Darwinia masonii translocation trial.

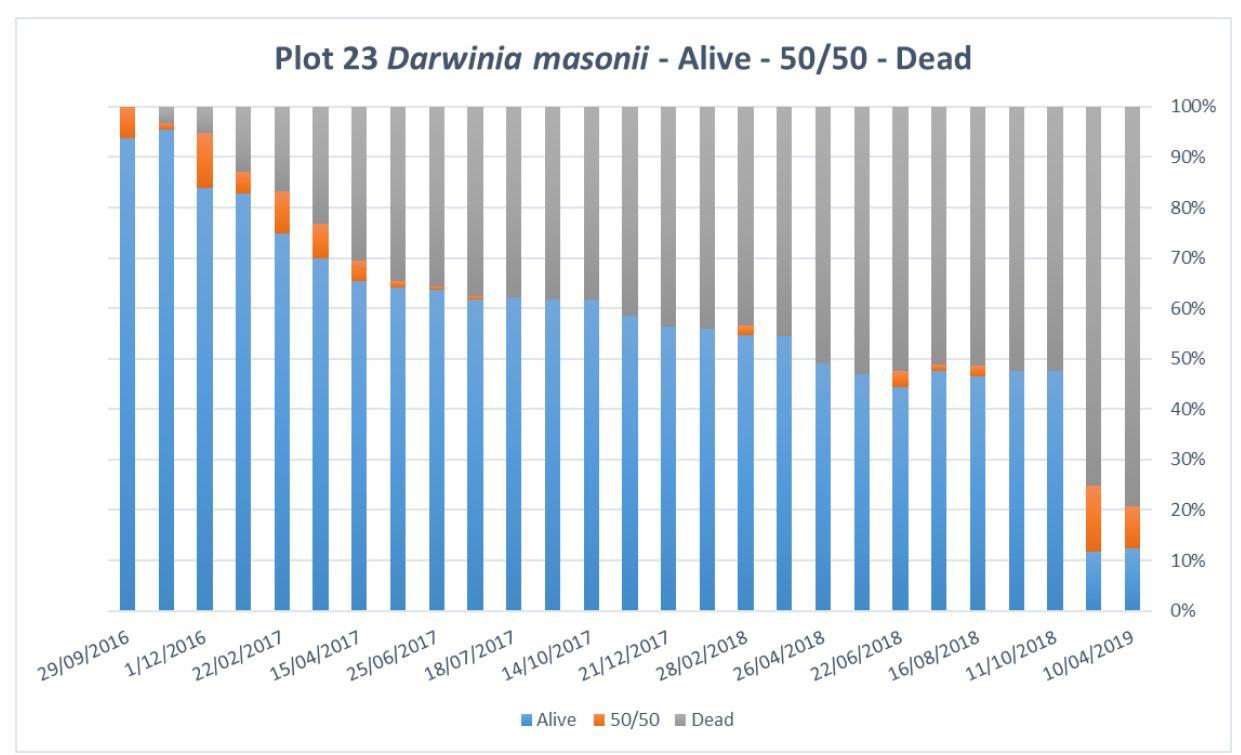
Figure 3 Survival of Darwinia masonii translocation seedlings at Plot 23

Darwinia masonii from Extension Hill had been held in nursery since before the ground was cleared for the mine pit in 2010. Some of this stock, which were cleared under Statement 753, were then cloned into juveniles and were able to be translocated back to the wild under a DPaW-approved Translocation Proposal in 2016. One translocation plot was planted out with 309 specimens which were grown in an irrigated, wire fenced plot. Further details are given annually to DBCA, with the most recent data outlined in the report entitled "*Darwinia Masonii and Lepidosperma Gibsonii Translocation Report December 2018 - December 2019*" (MGM, 2020).

The plot was among the first being developed in a series of other plots hosting translocated cloned D.masonii. Irrigation supply was turned off in 2018 and by late 2019 many of the plants had not survived as illustated in Figure 3. It influenced the decision to continue to water translocated plants in the other established plots, carrying over 3,000 D.masonii plants. It was also noted that the plants in Plot 23 were not as well dug nor watered in during the establishment phase and this may have resulted in a reduced medium term survival. That finding was used to improve the way that the subsequent plots were set up elsewhere as part of the overall Translocation Proposal.

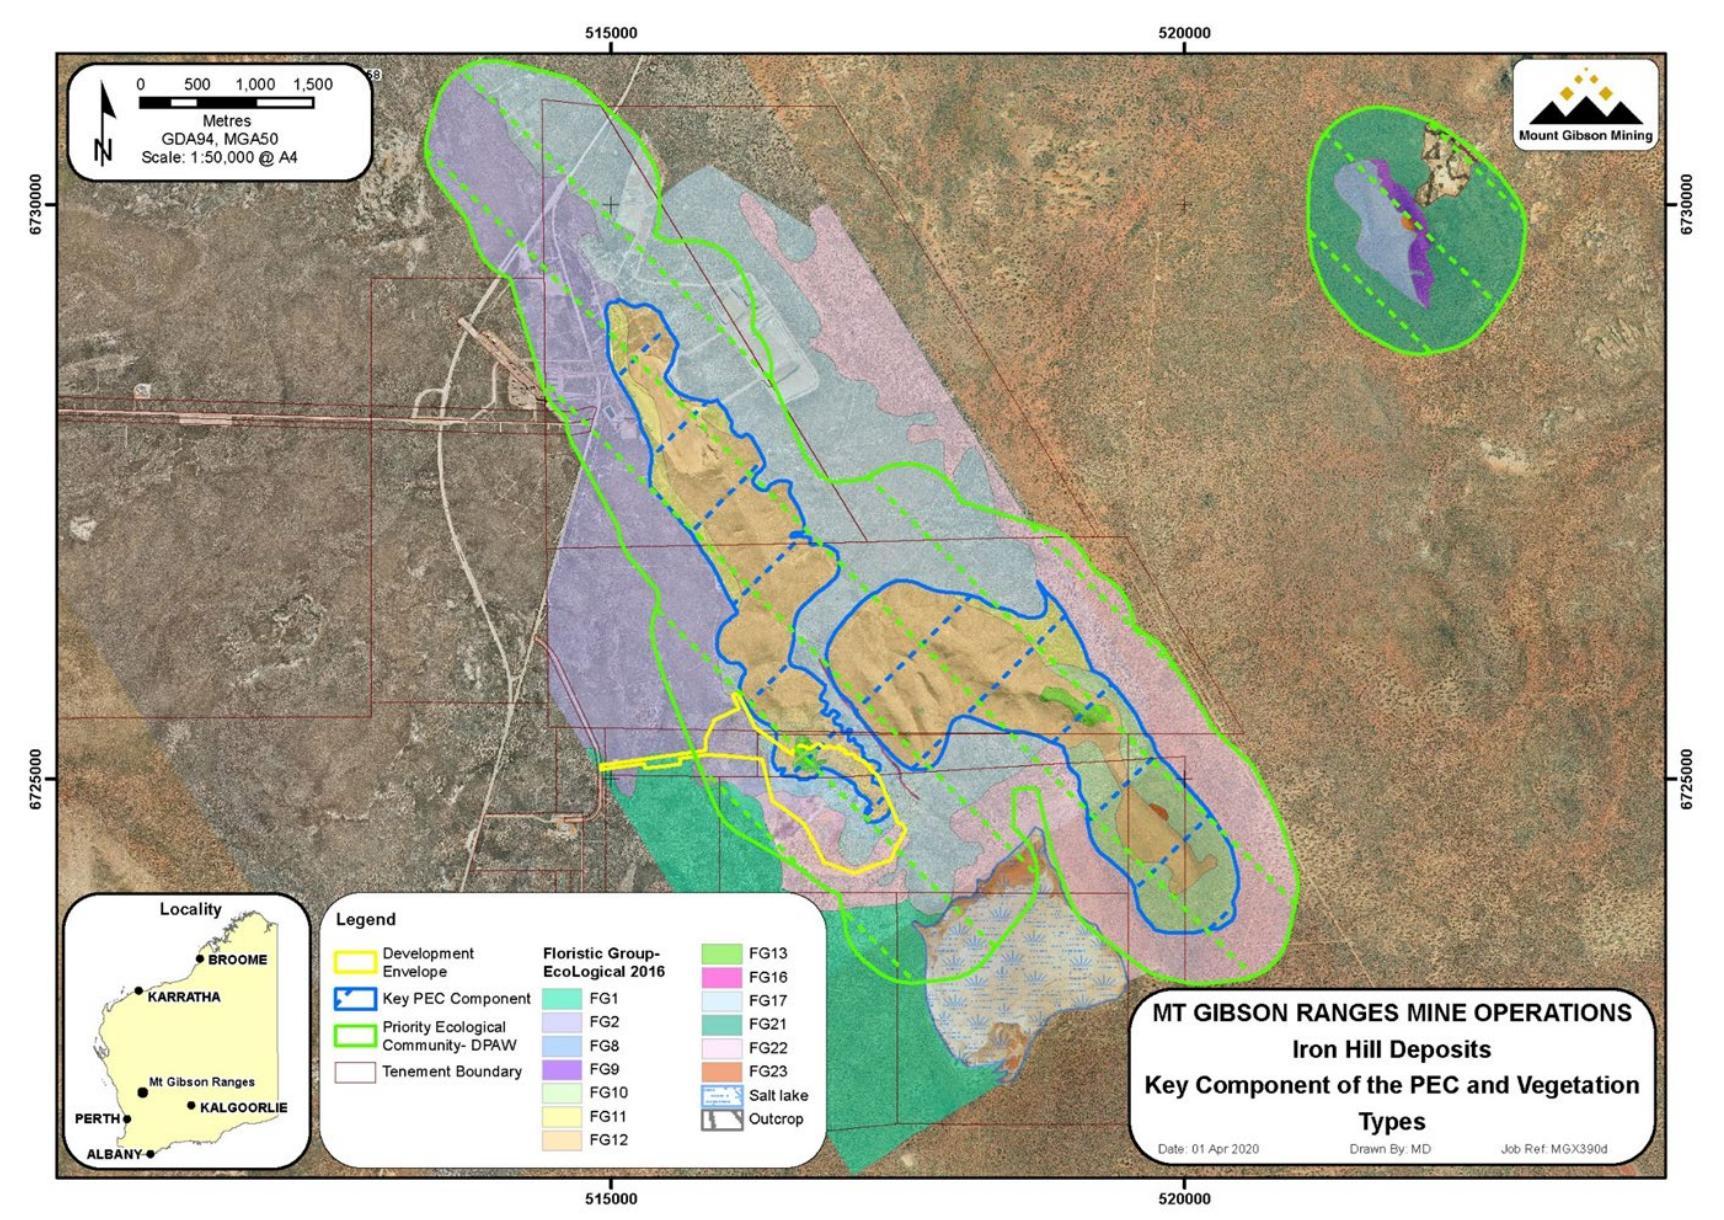
Figure 4 Mapped vegetation of the Project area

Eco Logical (2016) floristic groups are associated with the ironstone hills and slopes and, because of floristic compositions, are each considered to be key components of the Priority 1 PEC 'Mount Gibson Range vegetation complexes (banded ironstone formation)'. In the region the DBCA PEC is shown at two areas of occurrence and it is primarily mapped on and around the Mt Gibson Ranges. Figure 4 shows the DBCA PEC boundary in relation to the Project area and the key component of the PEC which comprises FG10, FG11, FG12 and FG13 from Eco Logical (2016). From Figure 4, MGM has demonstrated that the actual PEC boundary is significantly less than the original boundary previously generated by DBCA.

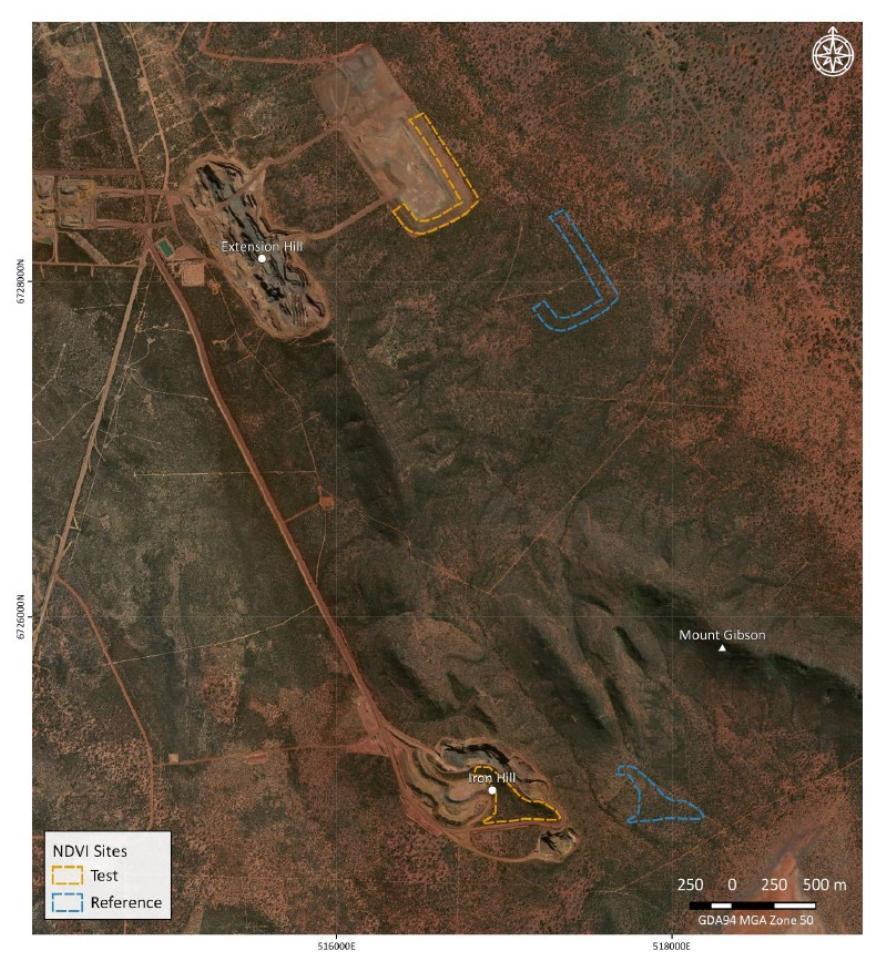
## Figure 5 Test and reference areas for analysis at each of Extension Hill WRL and within the Iron Hill mine domain.

Hydrobiology WA Pty Ltd conducted a Remote Sensing analysis of vegetation quality adjacent to the Extension Hill (EH) and Iron Hill (IH) mine pits (Figure 5). The analysis did these things over the course of five sequential years:

Sentinel-2 multispectral imagery was acquired in March of each year from 2016 to 2020 to capture potential changes in vegetation quality at reference and test areas. The Normalized Difference Vegetation Index (NDVI) was calculated as a proxy for vegetation cover and foliage quality as it provides a reliable and consistent measure of chlorophyll content (Higginbottom and Symeonakis, 2014; Eamus *et al.*, 2015). The assigned areas of similar setting, shape and areas are shown in Figure 5. Note the Iron Hill test area is vegetation that was approved for clearing but not cleared so the NDVI analysis was to see what temporary effect may be evident. At Extension Hill WRL, the rehabilitated areas (landforming; dressing; ripping; seeding) were completed prior to 2015, so five years of progression in revegetation is evident. As the method advances, broader areas for analysis will be examined in subsequent years. The March period was chosen as there is a strong effect of summer rains on Mid-west native vegetation quality.

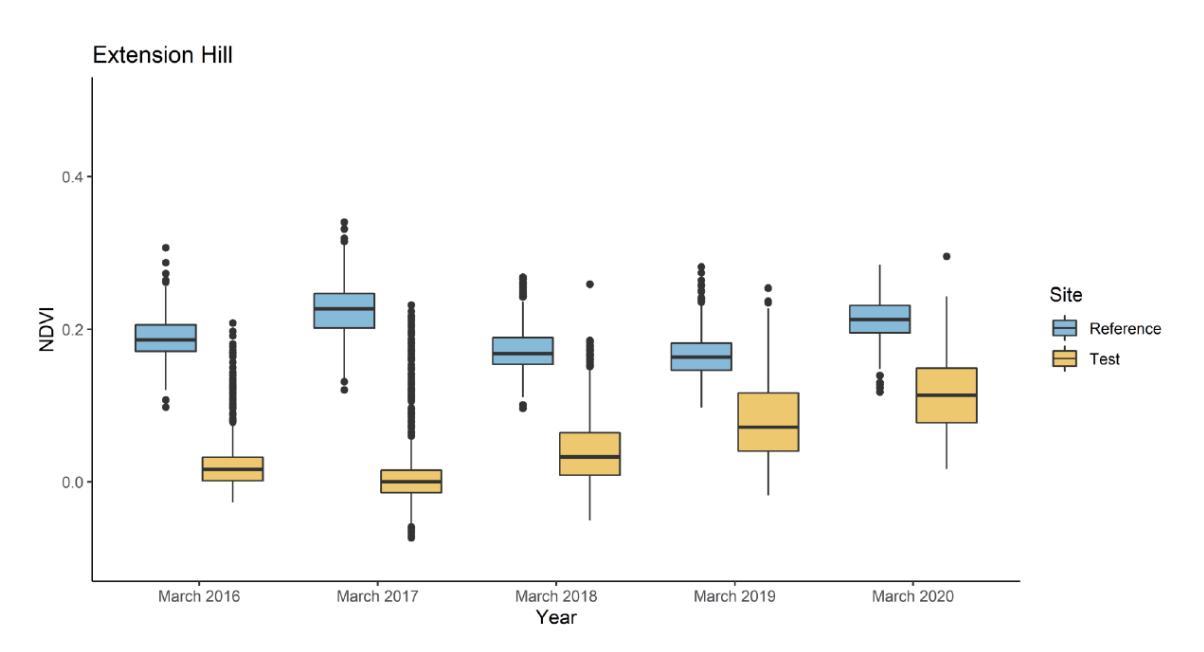
The combined results for this study show a general increase in vegetative quality / foliage volume at each of the Extension Hill rehabilitation area and Iron Hill uncleared area. NDVI at the Extension Hill test site shows a gradual year on year increase in NDVI and is indicative of the rehabilitation works which occurred and continuing to be ongoing there (Figure 6).

## Figure 6 Year-on-year change in NDVI at Extension Hill reference and test areas showing clear increasing trend in signal (foliage volume/fluorescence) particularly since 2018

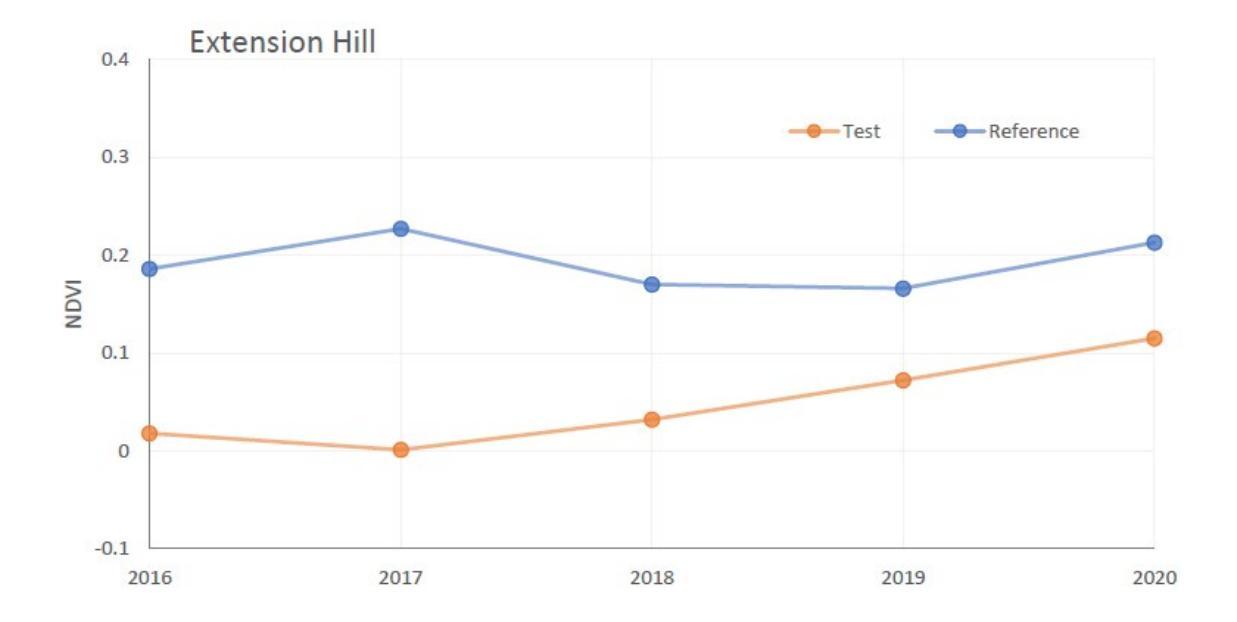
The trend in median NDVI is easier to view on Figure 7 as the linear trajectory of NDVI on the Test area is positive and tending to typical median NDVI at the Reference of approximately 0.2. At the current rate of progression, pending good growth and further seed germination with future rains, a period of another two years would be needed to meet the reference area five-year average NDVI level.

## Figure 7 Line trend at Extension Hill WRL showing typical NDVI of reference area and progression of NDVI on rehabilitated (test) area.

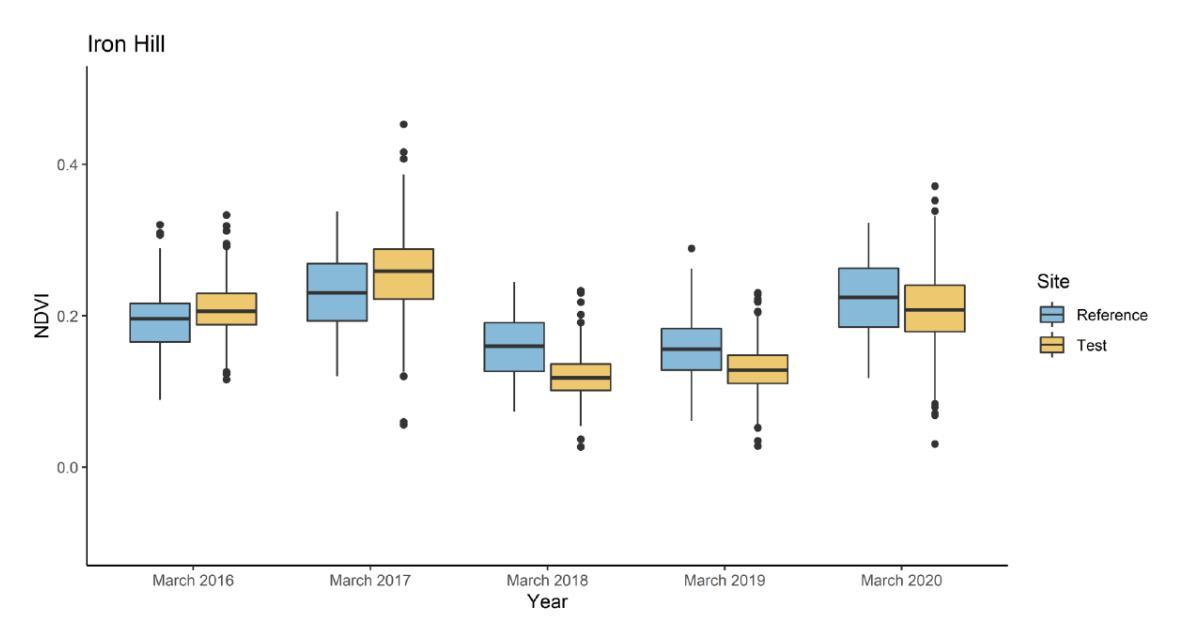
## Figure 8 Year-on-year change in NDVI at Iron Hill reference and test areas showing return to original NDVI signal (foliage volume/fluorescence) in 2020.

In particular, the NDVI at the Iron Hill mine domain area returned in 2020 to the values found there before mining operations began (Figure 8). Mining activity ended in early 2019. Note however that the median NDVI in 2018 and 2019 in the reference area was also reduced due primarily the generally dry years across the range (especially summer rainfall). The evidence shows that undisturbed native vegetation standing in immediate proximity to mining operations is only temporarily and slightly indirectly affected during the mining activities. MGM held an approval to take vegetation in the test area, although actual ore body mineralisation and efficiency in mining methods (ie less waste rock stripped and dumped) meant that direct loss of the test area of vegetation was not required.
